# **EASTFIELD PARK NORTHAMPTON**

## **STATE OF THE PARK**

(Footpaths, Facilities & Ground Conditions)

**MAY, 2019**

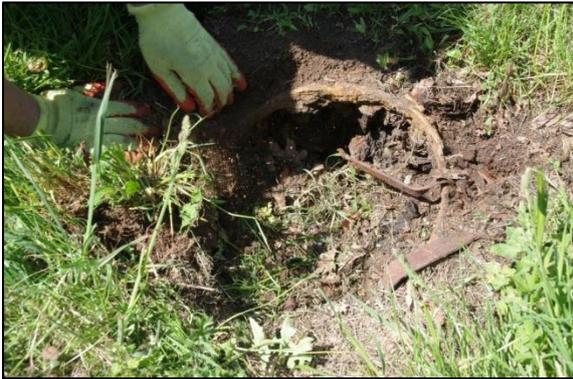
From time to time deep holes appear on the Park. Some of these are probably caused by animals, others by the illegal digging for buried artefacts (by metal detectorists). However, some seem to be caused by the collapse of underground chambers and these are the most hazardous for park users. One such hole was pointed out to Vic Smith immediately following the inspection on 23<sup>rd</sup> May (Fig 1). It requires urgent attention.

Fig. 1: Hazardous hole in Park surface.

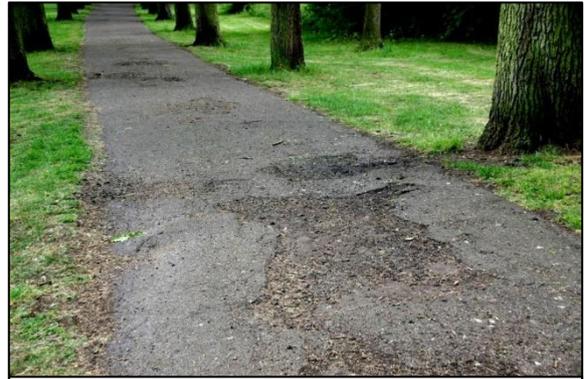
Apple Tree Walk, linking Kettering Road to the north-west corner of the Park, and its extension ('Cedar Walk') through the western margin of the Park to the Greenview Avenue entrance, are tarred pathways. Their surfaces are broken and crumbling in a number of places (Fig. 2). Ideally, they require remedial action in the near future.

Fig. 2: Broken surface of Cedar Walk.

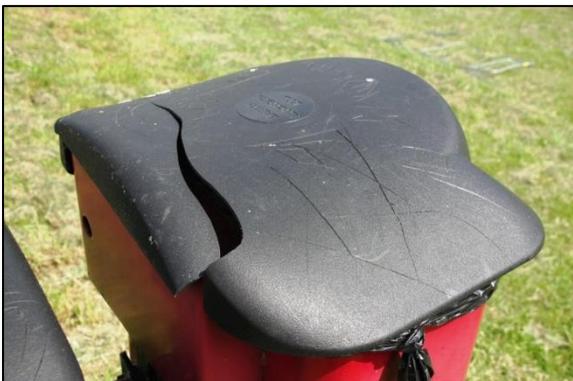
| Reference | Type | Comments (2019) | Assessment Scores | | | |
|---|---|---|---|---|---|---|
| D11 | Old red dog bin | Split lid | 3 | 4 | 3/4 | <b>2</b> |

In 2016, twenty waste bins were inspected. The majority of these (14) were the old-type red dog bins mounted on posts. By 2019, three of the dog bins had disappeared and two were deemed unsatisfactory. Dog bin D11 had a split lid (Fig. 3) and D13 was bent over at an angle making it difficult to use (Fig. 4). Both of these could easily be repaired.

Fig. 3: Damaged lid to Bin D11.

5. Two dog bins need repair or replacing and all bins require signs saying that they can be used for the disposal of bagged dogs' mess. Any new benches in the Park should be provided with waste bins nearby.

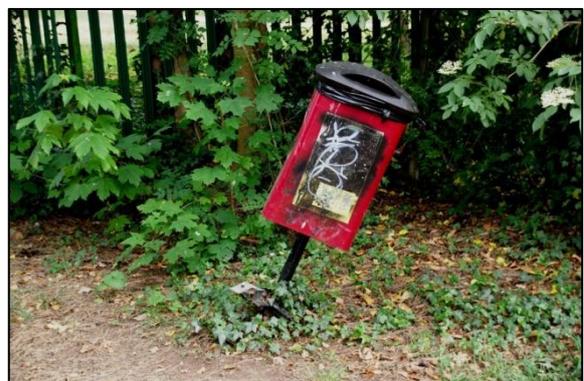
| Reference | Type | Comments (2019) | Assessment Scores | | | |
|---|---|---|---|---|---|---|
| D13 | Old red dog bin | Post bent over – needs renovating | 3 | 3 | 2/3 | <b>2</b> |

Fig. 4: Damage to Bin D13.

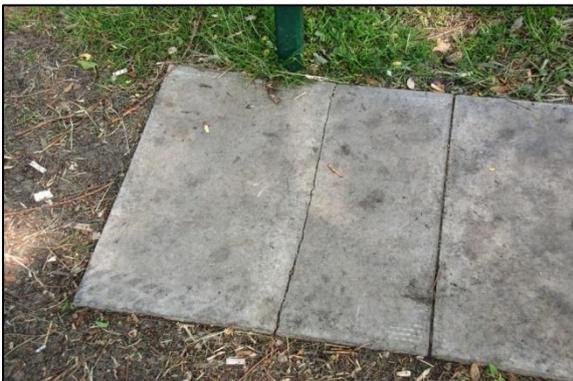
| Reference | Type | Comments (2019) | Assessment Scores | | | |
|---|---|---|---|---|---|---|
| S1 | Metal seat | Needs repainting; cracked paving slab at front | 4/5 | 3 | 3 | 4 |

All the benches are in good condition although some, particularly S1, would benefit from a coat of paint. However, there have been a number of complaints about the standard of work done in filling hollows and adding slabs to prevent further erosion. A number of the slabs are loose and one (in front of Bench S1) is already cracked (Fig. 5). In some cases the corners of slabs are exposed creating a hazard (Fig. 6) and elsewhere the old concrete foundations of the benches are left exposed.

Fig. 5: Cracked slab in front of Bench S1.

7. The depressions in front of existing benches have been partly filled and paving stones placed over areas most subject to wear. However, the work was not carried out to the highest standards and some slabs are already rocking or damaged. Remedial work needs to be carried out.

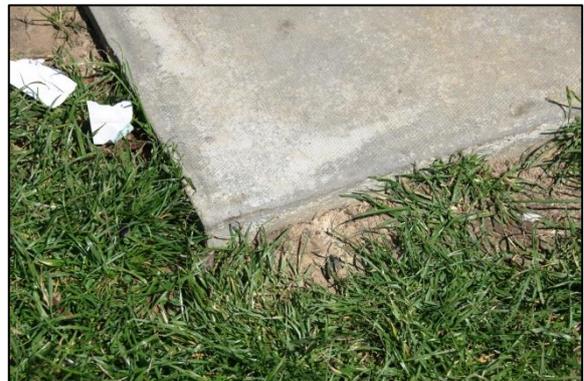
Fig. 6: Exposed corner of slab in Play Area.

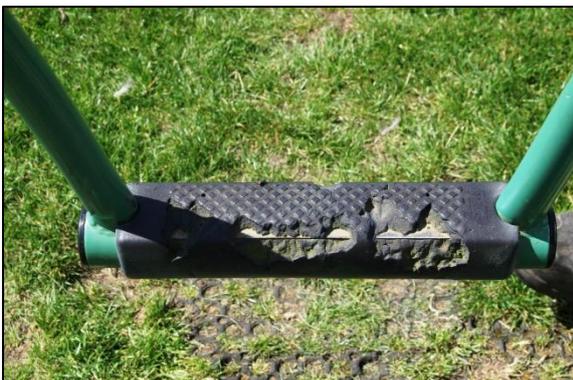
The damage to the Rocker treads has been described in previous *State of the Park* reports but this is the first time it has been raised as an issue of particular concern, mainly because it is now believed that the exposed metal could injure a child falling against it (Fig 7).

| <b>Apparatus: Component</b> | <b>Comments</b> | <b>Score</b> |
|--|--|---|
| <b>Rocker:</b> Treads | <b>Concern:</b> Badly worn. Exposed metal forms a hazard | <b>2</b> |

Fig. 7: Damaged tread on Rocker.

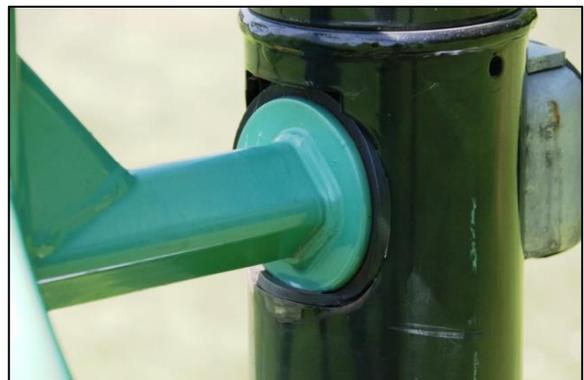
| <b>Apparatus: Component</b> | <b>Comments</b> | <b>Score</b> |
|--|--|---|
| <b>Rocker:</b> Mechanism | Bush worn (Fig. 8) – needs to be monitored | <b>3</b> |

Fig. 8: Worn bush on Rocker.

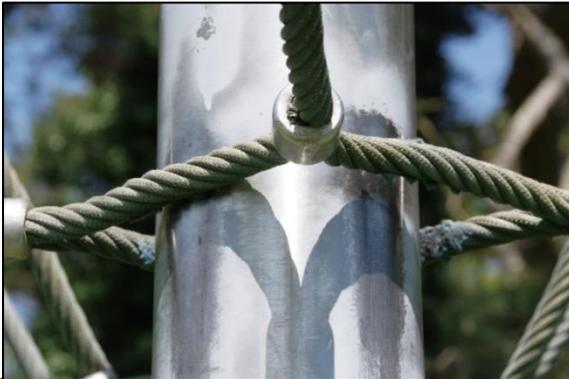
| <b>Apparatus: Component</b> | <b>Comments</b> | <b>Score</b> |
|--|--|---|
| <b>Pyramid climber:</b> Central pole | <b>Dangerous condition!</b> Movement in pole | <b>1</b> |
| <b>Pyramid climber:</b> Cables/Tension | Loose and rubbing against central pole (Fig. 9). | <b>1</b> |

Fig. 9: Loose cables & pole on Pyramid.

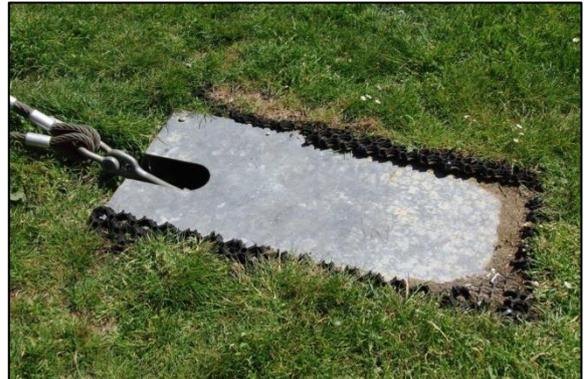
| <b>Apparatus: Component</b> | <b>Comments</b> | <b>Score</b> |
|--|--|---|
| <b>Pyramid climber:</b> Anchor points | One metal plate completely exposed (Fig. 10) – needs covering; others need monitoring for damage | <b>1</b> |

Fig. 10: Exposed anchor plate on Pyramid.

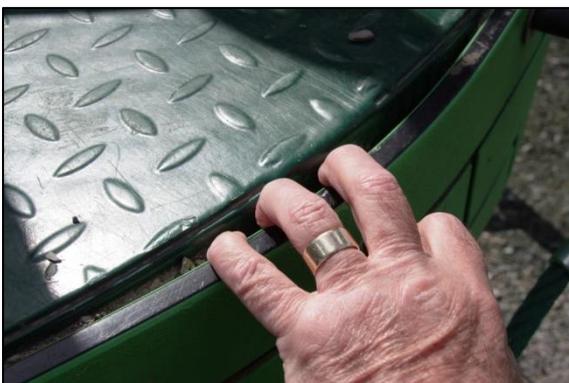
The equipment is generally in a good or satisfactory condition but there are a number of points that need attention, the most serious of which is a finger trap hazard at the top of the ‘rope’ ladder on the Mordred Castle (Fig 11). There is also concern over the exposed kerb along part of the rim of the surface surrounding the Swirl Roundabout (Fig 12). This is a trip hazard but could also prove harmful if a child fell onto it.

Fig. 11: Finger trap on Mordred Castle.

10. Work needs to be carried out to remove trip hazards in and around the Junior Play Area. Work on the entrances has been carried out but the rim of the Swirl Roundabout is still hazardous. The finger trap hazard on the Mordred Castle needs filling.

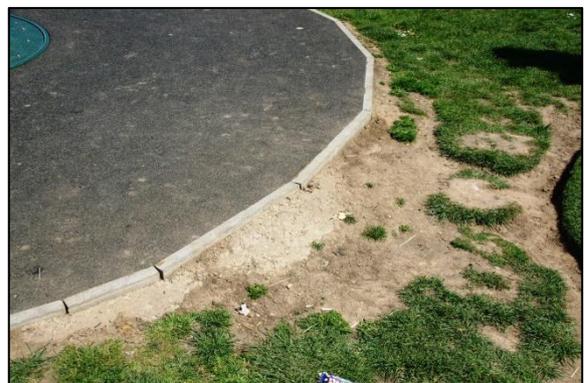
| <b>Apparatus: Component</b> | <b>Comments</b> | <b>Score</b> |
|--|--|---|
| <b>Swirl Roundabout:</b> ground surface | Good condition within circle (4). <b>Concern</b> over eroded ground exposing kerb edge hazard (3/2). | 3 |

Fig. 12: Hazardous kerb on Roundabout.

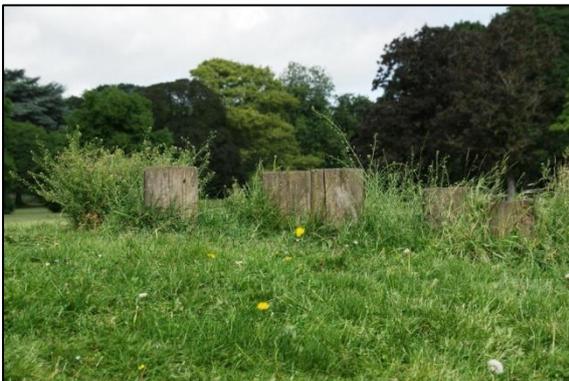
Having been restored by volunteers in autumn, 2016, the mound itself is still in reasonably good condition and was given a score of ‘4’. At the time of the inspection it did, however, need strimming (Fig 13).

Fig. 13: Weeds around posts on 'Monster'.

11. Rotten or loose posts on the 'Monster' play mound need repair, replacement, or removal and the holes filled. The whole area needs regular strimming.

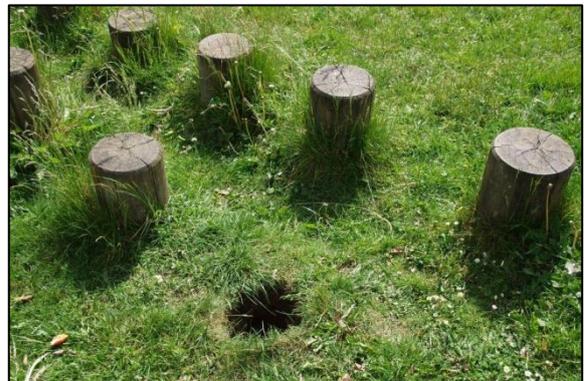
Some of the wooden posts are in very poor condition. They were either rotten at the base or loose in their sockets and received a score of only ‘2’. Of particular concern is the fact that if these posts are removed by vandals the hole left behind is a serious hazard (Fig 14). Ideally, the damaged posts need replacing or resetting. A less satisfactory solution, as has sometimes been done in the past, is for the posts to be removed completely and the resulting holes firmly filled.

Fig. 14: Hazardous post hole on 'Monster'.

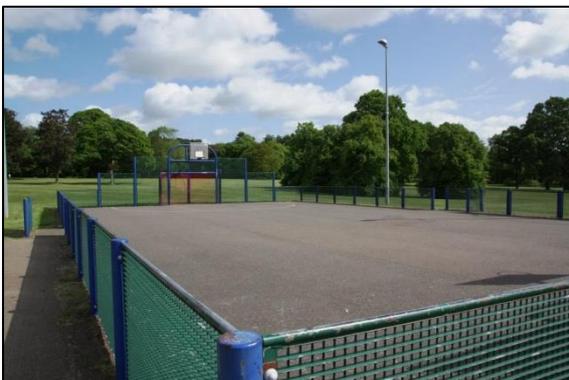
The MUGA has hardly changed in the past year. It is in reasonably good condition (Fig 15) but the fence (given a score of ‘3’) needs painting. The playing surface is in reasonably good condition and was scored ‘4’ but there is a pothole outside the area (Fig. 18) that needs filling.

Fig. 15: MUGA in reasonable condition.

12. The MUGA fence would benefit from a coat of paint and one pothole, outside the games area, should be filled.

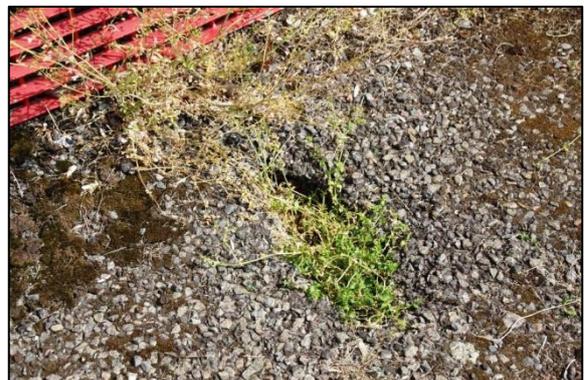
Fig. 18: Small pothole outside MUGA.
