EASTFIELD PARK NORTHAMPTON

STATE OF THE PARK

January, 2016

Eastfield Park Management Committee

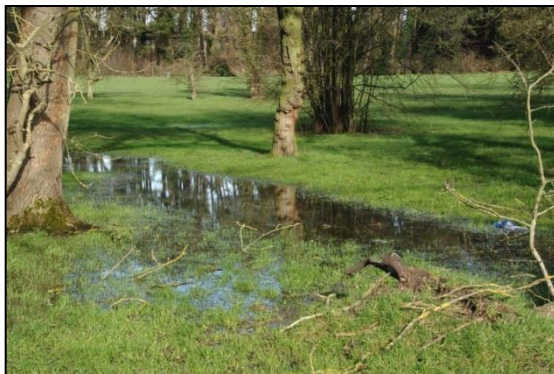
Unsurprisingly, in view of the exceptionally wet weather experienced across the country this winter, much of the park was waterlogged in January and February with the puddles of standing water especially around the eastern end of the Lake. However, this situation is not unusual as Figures 1 and 2 show (one taken in February 2016 and the other in February 2013). (Figure 2 is taken looking in the opposite direction to figure 1 but shows the same area of the Park.)

Figure 1: Standing water to the east of the lake
– February, 2016

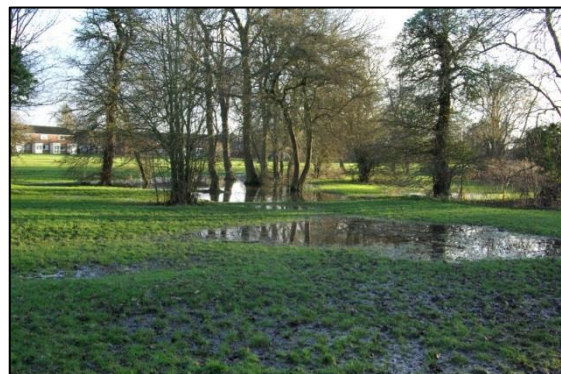
Figure 2: Standing water to the east of the lake
– February, 2013

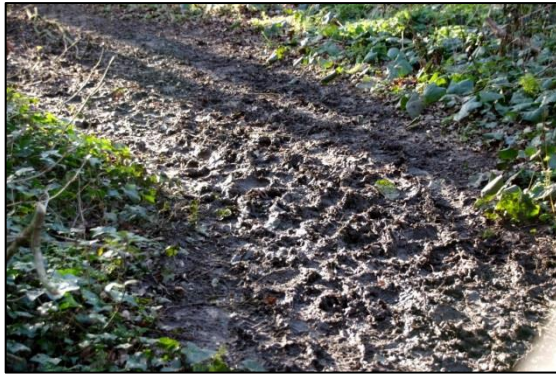
With the presence of so much surface water, and soggy conditions elsewhere, people tend to make greater use of certain routes through the Park, wearing away grass and rendering these pathways themselves muddy and in some cases unusable (Fig. 3). The vehicles used by contractors collecting litter and dogs' mess from bins are unable to access much of the Park and a number of bins go unemptied. Where contractors use Mallard Walk to access the bins by the lake, the new pathway is deeply rutted and inconvenient for walkers (Fig. 4).

Figure 3: Muddy path in a drier part of Eastfield Park.

In the past the FoEP have called for improved drainage to the Park but NBC has argued that this would not bring sufficient public benefit for the cost involved. It must also be taken into consideration that Eastfield Park may be performing a valuable environmental service by holding water back, rather like a giant sponge, reducing the risk of surface water flooding in residential areas lower down the Walbeck basin. It seems possible that any improvement to the Park's drainage could increase the risk of flooding elsewhere. A soggy Park in winter may be something that has to be tolerated but the situation can be improved by the construction of additional all-weather paths as suggested by the FoEP.

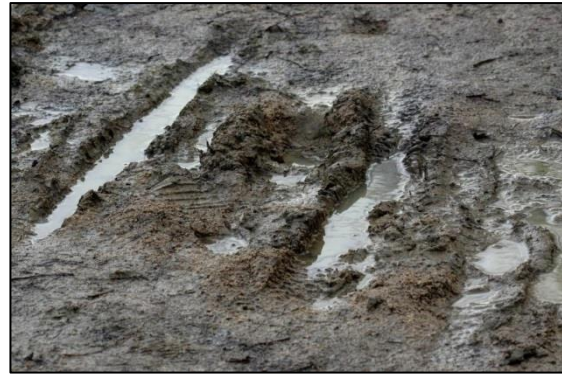
Figure 4: Mallard Walk (new 'all-weather' pathway) damaged by vehicles.

The poor state of the new all-weather pathway (Mallard Walk) as it passes by the lake is at least partly due to the fact that, because the land here is generally firmer and drier than elsewhere along the path's route, it was not constructed to the same high standard.

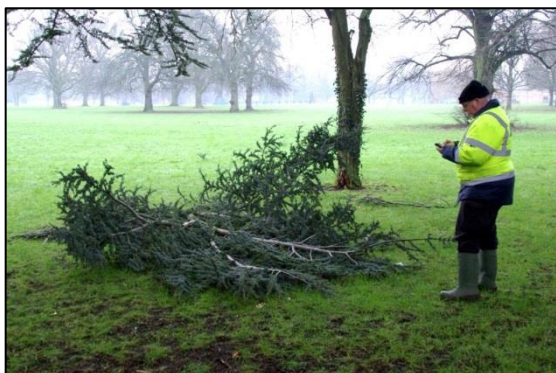
A number of trees have been damaged and some very large branches brought down by the severe winter storms of 2015-16 (Figs. 5&6).

Figure 5: Park Ranger, Kevin Skerry, inspects a fallen branch.

Storm damage to trees could, however, be reduced if trees received better maintenance throughout the year. In 2014, dead trees were marked for felling in 2015. In order to protect nesting birds, no work was carried out on the trees last spring. Later in the year weather conditions were unfavourable. The matter is now becoming urgent especially for people who have gardens bordering the Park. However, the FoEP do not want to see all dead trees cut down; some provide valuable nesting sites for birds and habitats for a variety of invertebrates. In the case of one particular tree, it has been agreed that, if possible, only the upper branches should be removed to make it safe, while keeping the trunk and lower branches available for nesting woodpeckers.

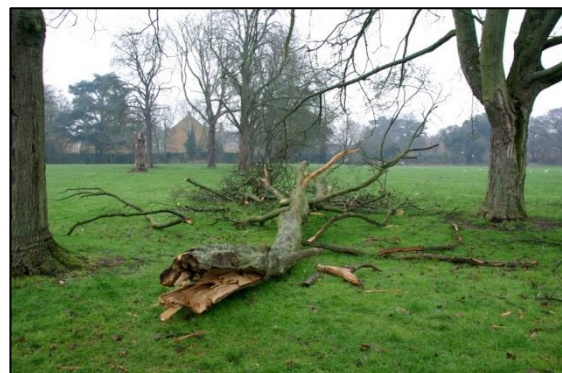
Figure 6: A very large branch brought down by a severe storm.

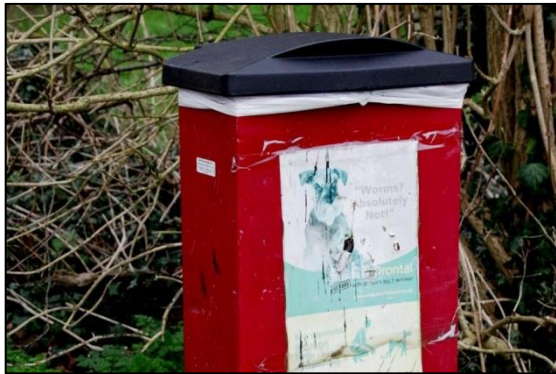
Figure 8: Dog bin suffering from reasonable wear and tear.

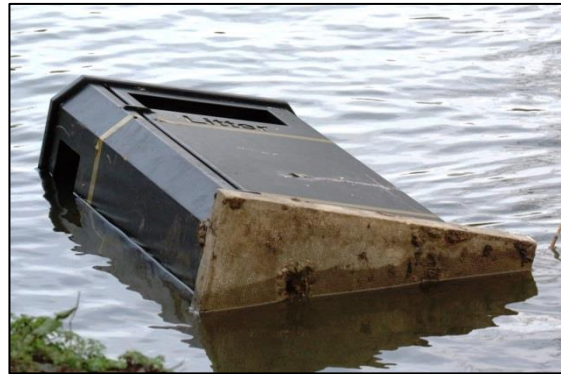
There is a certain amount of fair wear and tear to facilities within the Park (e.g. Fig. 8) but most of the damage to structures is caused by deliberate anti-social acts, ranging from minor incidents of scrawls and scribbles on seats to the deliberate destruction of facilities such as dog and litter bins. Last year the seat by the lake outfall was tipped into the water and this year the same has been done to the adjacent litter bin (Fig. 9). One of the near-by dog bins has had the lid completely destroyed by vandals (Fig. 10) and a new sign prohibiting swimming and boating erected by NBC was damaged within a week (Fig. 11).

Figure 9: Litter bin uprooted and dumped into lake (near lake outfall).

Eastfield Lake is surely the 'jewel in the crown' of Eastfield Park; the trouble with crown jewels is that they can attract undesirable attention! An NBC officer has already suggested that when the litter bin is recovered from the lake it should not be returned to its original site, yet the FoEP wants every seat in the Park to have a litter bin alongside it. The Park Ranger has commented that almost all the trouble in Eastfield Park occurs close to the seat by the lake outfall. Perhaps the best solution is to move both seat and litter bin elsewhere. The 'No boating / No swimming' sign has already been removed and will be relocated by the path between the lake and the new play area.

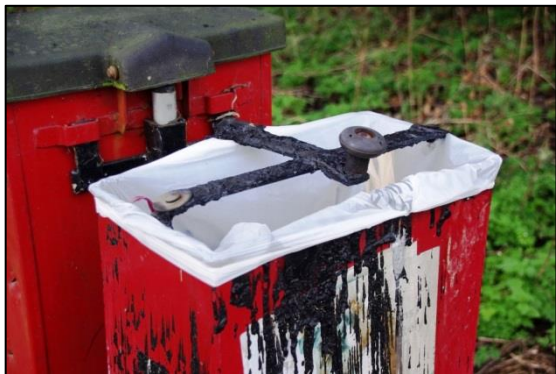
Figure 10: Dog bin near lake outfall suffering from deliberate act of vandalism (fire).

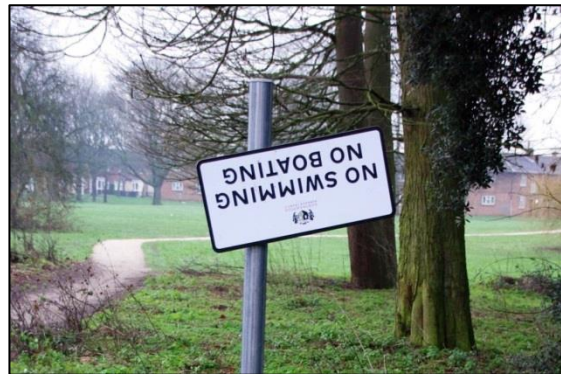
Figure 11: New sign near lake outfall vandalised with one week of being erected by NBC.

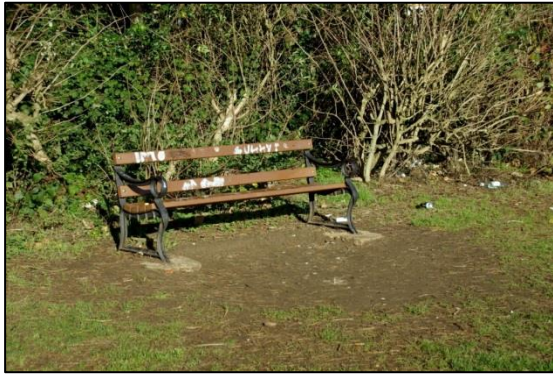
The park benches attract considerable amounts of graffiti (Fig 12). They are generally in satisfactory condition but the metal one on the north side of the lake (S1) is almost pristine suggesting that this is a good design for the Park. (The metal litter bin next to it is also

Figure 12: Seat near football pitches (S2) with graffiti, litter and muddy depression in front.

almost pristine.) Two of the benches (S2 & S5, Figs 12 & 13) also have muddy depressions in front of them. These need to be filled in with a suitable material.

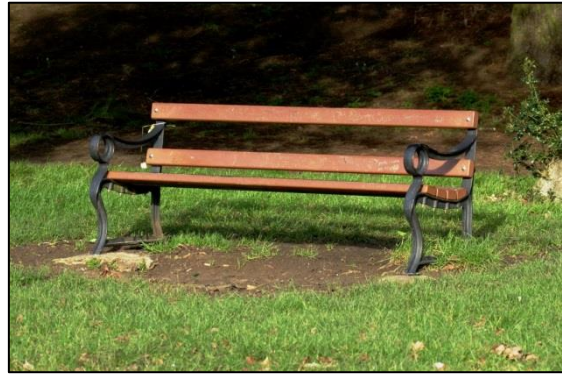
Figure 13: Seat near bottom pond (S5) with slight graffiti and muddy depression in front.

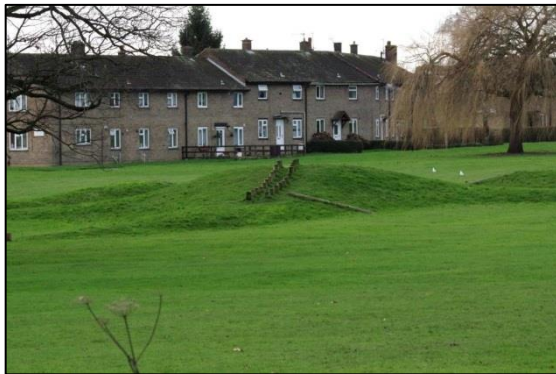
The 'Eastfield Monster' play mound (Fig. 14) is satisfactory although the ground is badly eroded at the top of the mound (Fig. 15) and some logs have been removed. (Some were deliberately damaged but mostly they seemed to suffer from natural decay.)

Figure 14: The 'Eastfield Monster' play mound is reasonably sound but repairs are needed.

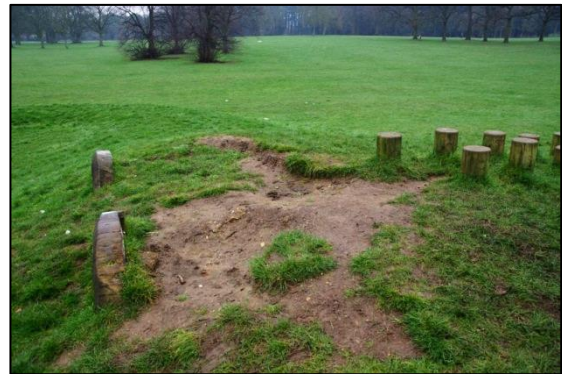
Figure 15: The top of the 'Eastfield Monster' play mound is badly eroded.

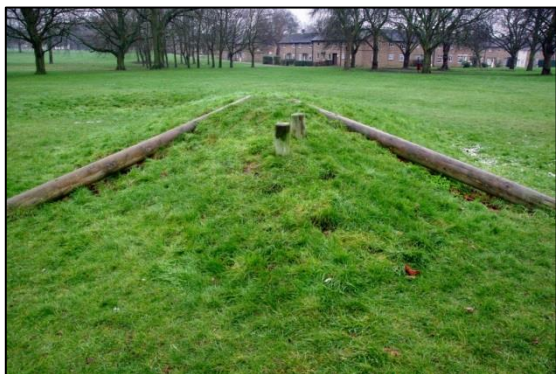
Figure 16: Some posts are missing from the 'Eastfield Monster' play mound.

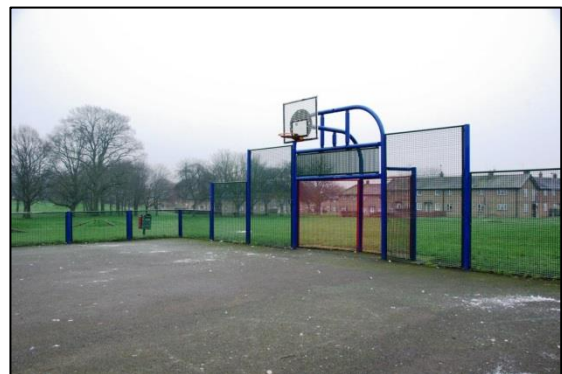
Figure 17: The MUGA is in reasonably good condition.

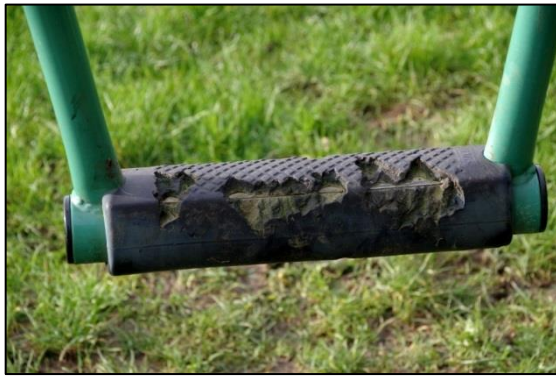
The MUGA (Fig. 17) is in reasonably good condition. The play equipment in the ‘senior play area’ is mostly in a good or satisfactory condition but there are signs of wear to less durable structures (Fig 18). Two of the ground fixings for the climbing pyramid have been exposed and one in particular (Fig. 19) may present a trip hazard especially to children using the apparatus. The mini trail through the Lakeview Spinney is also in satisfactory condition but urgently needs weeding. This is one situation where it would be sensible to use a chemical herbicide since mechanical weeding is likely to damage the path.

Figure 18: Less durable surfaces on the senior play equipment are showing signs of wear.

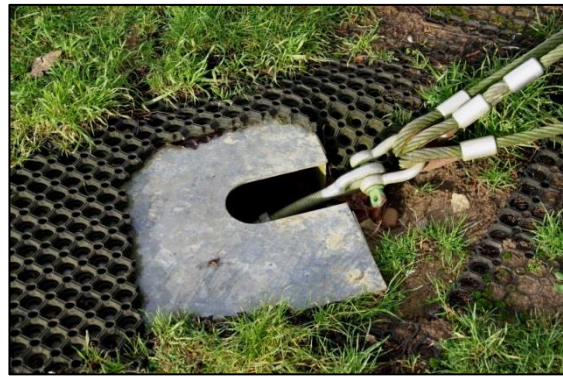
Figure 19: Exposed ground fixings for the climbing pyramid may represent a hazard.

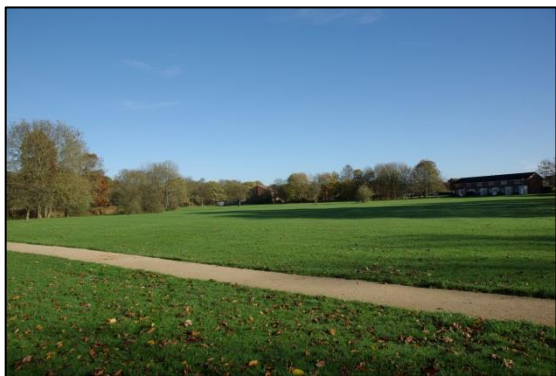
Other surfaced pathways in the Park are generally satisfactory. Mallard Walk (Fig. 20) is in good condition apart from where it passes close to the Lake (already referred to) and some slight damage at its southern end. The tarmac on older pathways is beginning to break up in places (Fig. 21) and this requires monitoring and remedial action if it becomes a hazard.

Figure 20: Most of Mallard Walk is in good condition and well used.

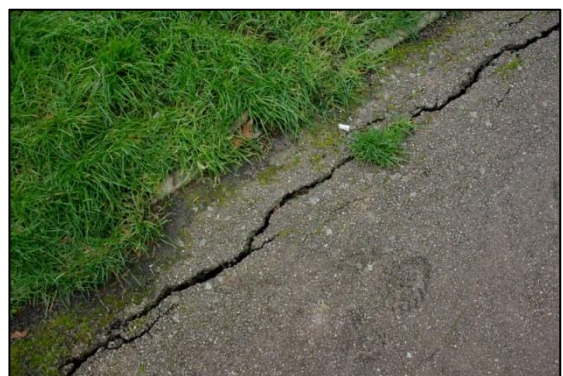
Figure 21: The tarmac on some older paths is showing signs of deterioration.
