# **EASTFIELD PARK NORTHAMPTON**

## **STATE OF THE PARK**

(Water Resources & Vegetation)

**November, 2018**

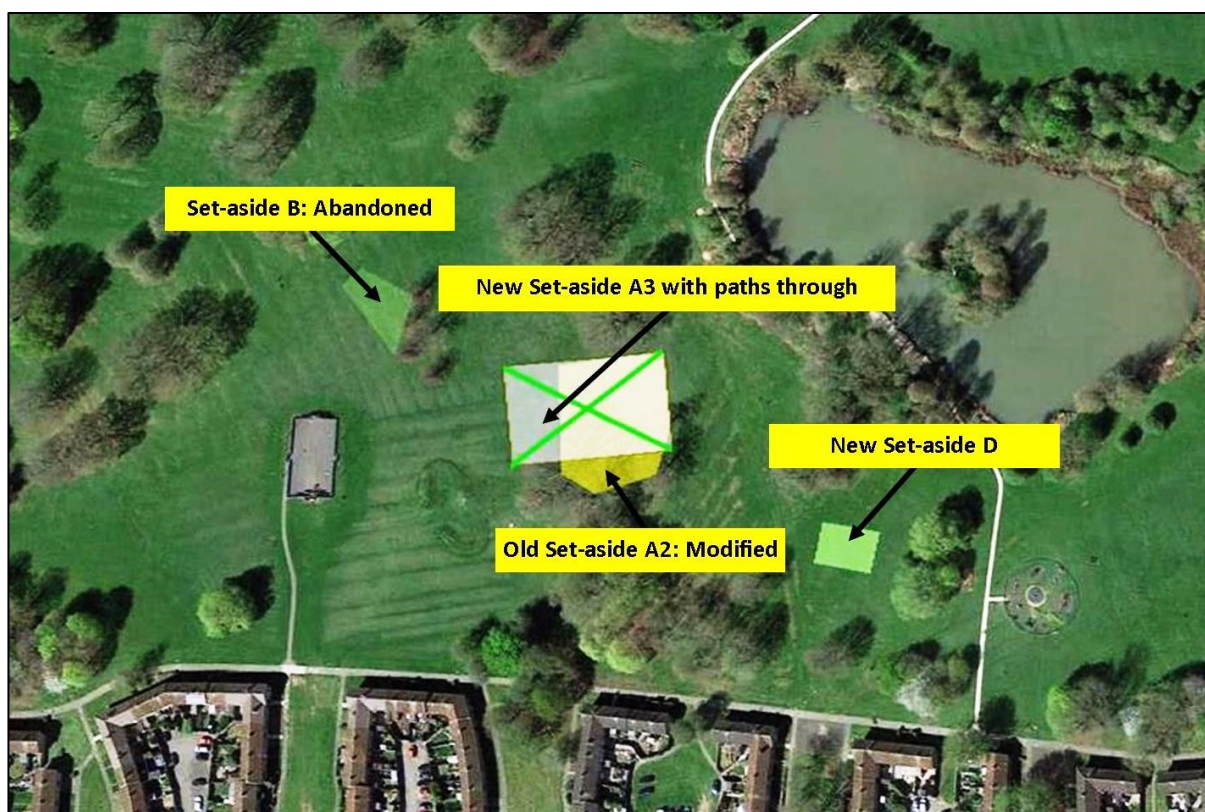
In accordance with plans agreed at the September 2017 EPMC meeting, two areas in the Parkland Zone were ‘set aside’ from the usual mowing regime and not mowed at all until late in the year (Area A2 and D in Fig. 1). The areas were discussed with Wayne Wright from Amey plc and then marked out by FoEP volunteers in March. Because of the unusually wet weather, the markings had almost disappeared by the time the grass came to be cut but the areas actually left were very similar to those requested by the FoEP. As planned, the diagonal pathways were cut through Set-aside Area A3.

**Fig. 1: Set-aside areas agreed for 2018.** Set-aside Area B (2017) was abandoned and replaced with a new Set-aside Area D for 2018; Set-aside Area A2 (2017) was modified to form the extended Set-aside Area A3 (2018) with paths running diagonally across the area.

1. The grassland areas in the Park are now being well managed by idverde. It is recommended that the same areas set aside in 2018 be set aside in 2019 and that they be surveyed in July of that year.

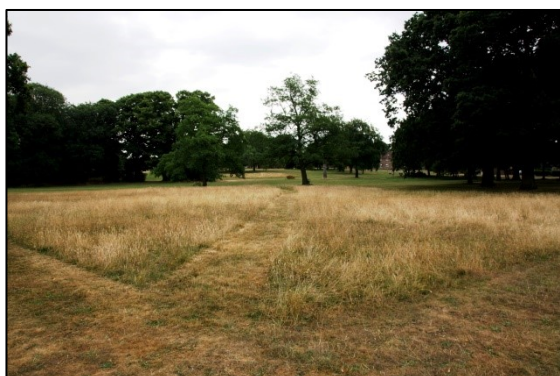
**Fig. 2: Set-aside Area A3 in July with Area D in the background.** Note the diagonal path for walkers.

Both areas (Figs. 2 & 3) were examined by Matt Johnson (the local Wildlife Trust's Living Landscapes Manager) accompanied by Vic Smith (FoEP Chair) on 7<sup>th</sup> August 2018, rather later than preferred. Because of the hot dry weather during May, June and July, vegetation in the set-aside areas was stunted and withered and many of the plants were difficult to identify. It was therefore decided not to compile a list of species as in previous years but simply to recommend that the same two areas be set aside in 2019.

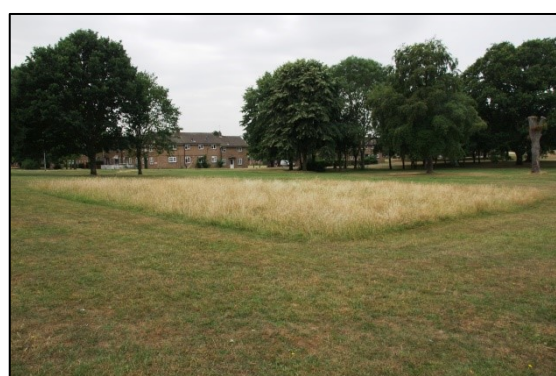
**Fig. 3: Set aside Area D in July, 2018.**

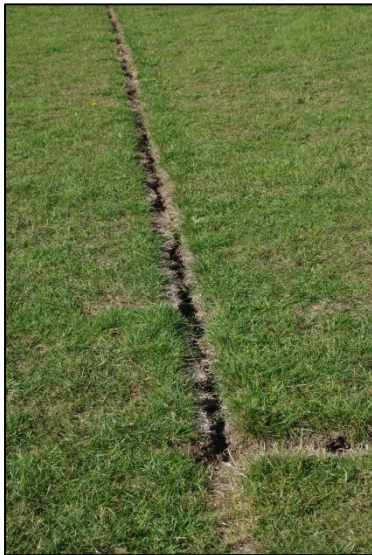
**Fig. 4:** Deep cracks along the lines marked out for the football pitches (September, 2018).

Although August and September were not as dry as the preceding three months, they also had less than average rainfall. On 2<sup>nd</sup> October 2018, Vic Smith walked around the Park with Nicola Clarke (Midlands Horticultural Manager for idverde). During this time they noted deep cracks in the Park's surface caused by the extremely dry conditions. Although this relates to ground conditions rather than vegetation, it is relevant to mention it here since many of the deepest cracks followed the white lines marked out for the football pitches (Fig. 4). The mixture used to mark out the lines kills the grass, the roots of which would otherwise bind the soil together and significantly reduce the chance of cracks developing. There is probably little that can be done about this but it does illustrate the importance of the Park's grass cover. The lines used to mark out the set-aside areas do not kill the grass but they are deliberately much less permanent.

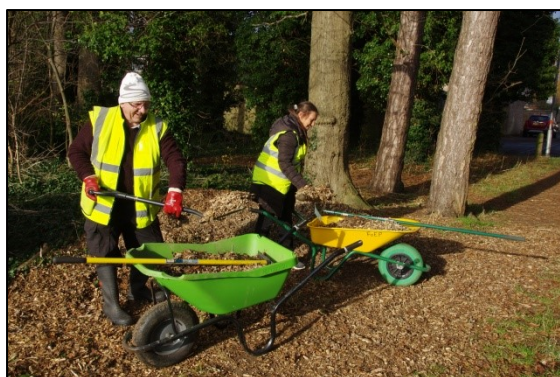
**Fig. 5: FoEP volunteers collect chippings left at a convenient site by idverde contractors (Nov. 2018).**

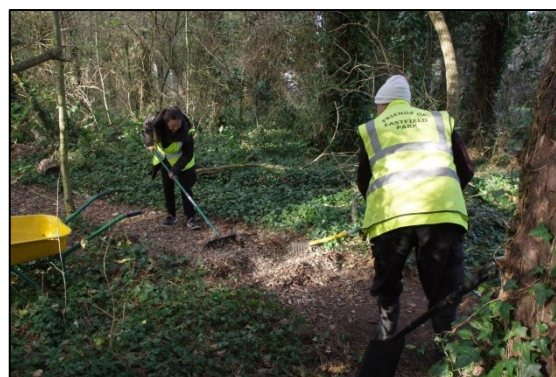
Many of the pine trees in the old spinneys are diseased and dying. Gaps in the woodland are being filled by self-seeded 'weed trees', brambles and nettles. Management by contractors in the last few years has concentrated on felling dangerous trees, leaving trunk sections in piles for the benefit of wildlife. Management by the FoEP has concentrated on maintaining pathways through the spinneys and Buttermere Scrub. This has included removing nettles and brambles along pathways and cutting back overhanging branches. Paths are also being covered, where possible, with wood chippings. Considerable progress has been made during 2017 and 2018 on the pathway from the Skiddaw Walk entrance, through the Lakeview Spinney, to the Booth Lane Entrance. The whole of this pathway was cleared in 2017 and chippings are being added in 2018 (Figs 5 & 6).

**Fig.6: FoEP volunteers spread chippings on path through Lakeview Spinney (November, 2018).**

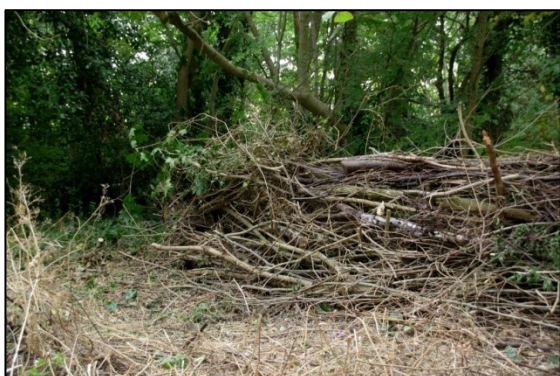
During 2017 and the first half of 2018 a considerable number of bushes and smaller ‘weed trees’ were removed by FoEP volunteers from the margins of the wooded areas, particularly the lake embankment and the areas between the ponds and the open parkland. This was done to open up these areas, making it safer for walkers using the Park and generally improving the appearance of these areas. This work, however, generated a considerable quantity of brushwood, some of which was used to create new habitats such as hibernacula and ‘hedgehog hotels’ or build ‘dead hedges’ (Fig. 7), but which was mostly piled up in the wooded areas near to the ponds (Fig 8). This brushwood presented a fire hazard during the hot dry summer in 2018 and is possibly detrimental to trees it is piled against.

**Fig. 7 Brushwood used to create ‘dead hedge’ to protect culvert near top pond (July, 2018).**

It has long been the policy of the FoEP not to export green waste from the Park. If the brushwood can be chipped or shredded it will take up much less room and can possibly be used elsewhere in the Park as mulch or a dressing for pathways. There are numerous locations in the Park where bushes or trees need to be cut down or coppiced and this cannot be done because the waste piles should not be added to. A high priority therefore needs to be given to dealing with this issue.

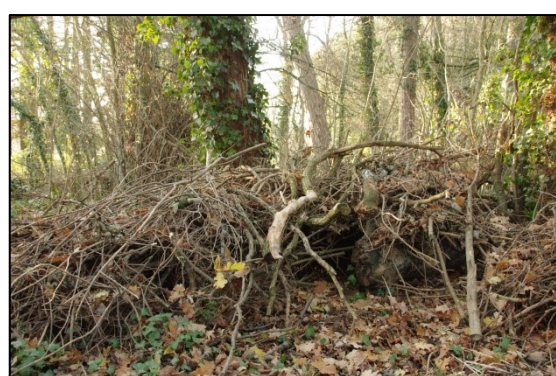
**Fig. 8: Piles of brushwood accumulated from bush clearance by FoEP volunteers.**

3. A strategy should be implemented for dealing with branches and other green waste produced when pruning and coppicing bushes and trees in the Park. (At present most of it is stored in the wooded areas where it presents a fire risk.)

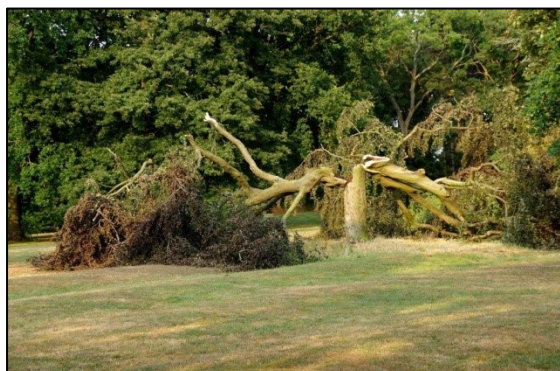
The extremely dry weather during the first part of the 2018 summer undoubtedly stressed many of the large trees in the Park's Heritage Zone making them vulnerable to later storms. In some cases large branches split off trees even in the absence of strong winds, a phenomenon known as 'sudden branch drop syndrome'. It was pleasing to note how rapidly major incidents were dealt with by idverde.

Sometime between 25th and 26th July, a large beech tree in Eastfield Park suffered major damage (Fig. 9). The two main branches of the tree split away from the trunk but remained resting against it in a precarious position. The situation was potentially dangerous, especially to any children attempting to climb the branches. The situation was reported to NBC Street Services on-line on Thursday, with a follow up call and pictures on Friday morning. The tree was made safe later that Friday by specialists from idverde (Fig 10). The smaller branches were chipped and the chippings left in the Park for FoEP volunteers to use.

**Fig. 9: Damaged beech tree in the Park's Heritage Zone (27 July, 2018).**

5. Contractors are responding rapidly to seriously damaged trees in the Parkland Zone and it is hoped that they will be proactive in identifying hazardous trees throughout the Park.

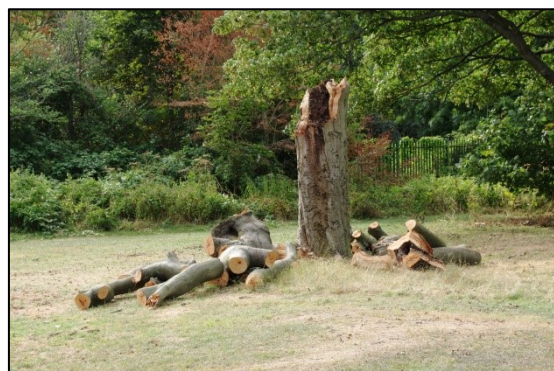
**Fig. 10: Damaged tree made safe within two days of being reported (30 July, 2018).**

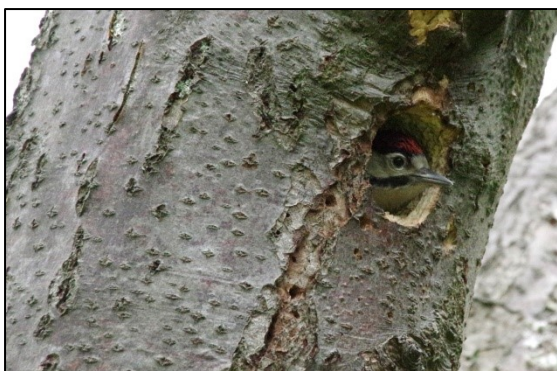
Another casualty during 2018 was the dead tree used in 2015 by a family of greater spotted woodpeckers (Fig 11). The tree fell sometime during November 2018 (Fig 12).

**Fig. 11: Woodpecker nest in dead tree in Heritage Zone (02 June, 2015).**

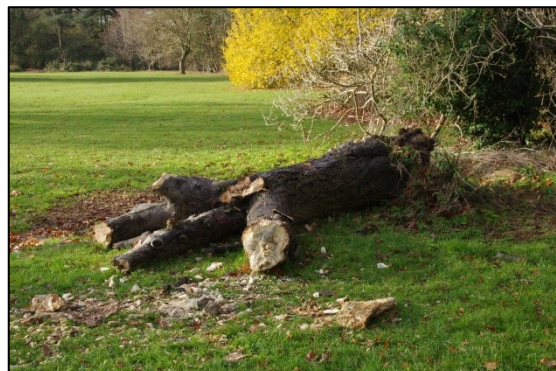
**Fig. 12: 'Woodpecker tree' fallen in November 2018.**

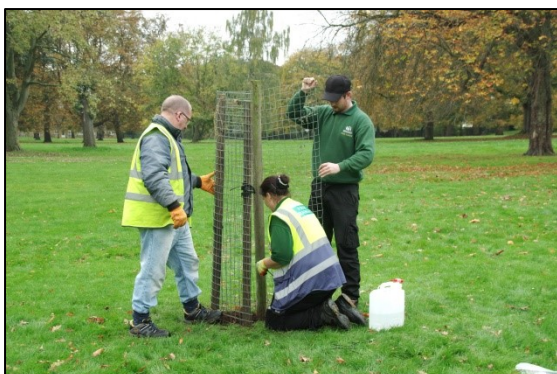
The Eastfield Park Management Plan calls for trees lost from the Heritage Zone to be replaced with new trees. In recent years a number of trees have fallen or been cut down and the FoEP were given permission to plant four tree whips (two oak and two beech) in specified locations in October 2017. Originally, the trees were surrounded by wire cages put in position with help from NBC Park Rangers (Fig. 13). The cages were, however, repeatedly pushed over and it was eventually decided to abandon them but to mark circles around the whips (Fig. 14) to make them conspicuous to tractor drivers mowing the Park.

**Fig. 13: FoEP and Park Rangers planting whips and protecting them with cages (26 October, 2017).**

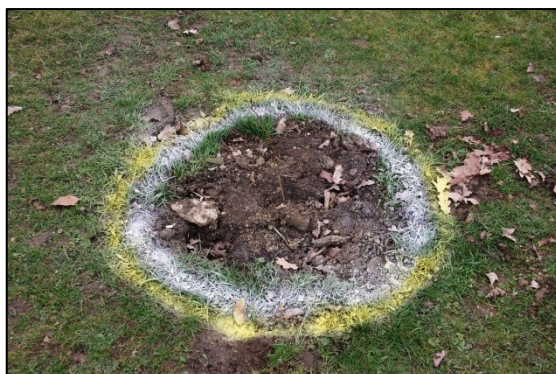
**Fig. 14: Cage gone and whip marked with circles (22 March, 2018).**

Consideration needs to be given to providing better protection for any additional trees planted in this part of the Park. Trees planted in the spinneys are less likely to suffer this kind of damage but are more likely to suffer from competition with other plants.

6. More trees should be planted in the Parkland Zone but greater attention needs to be given to protecting new trees from deliberate and accidental damage.

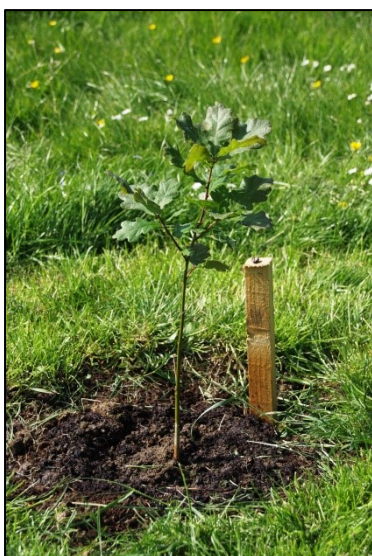
The tree whips did well during the wet spring. By May, one of the oak whips had been damaged and had to be replaced but both beech whips and the other oak were doing well (Fig. 15). The whips were watered heavily every two to three days during the drought period (May to July) and grass and weeds removed from the area surrounding them.

**Fig. 15: Oak whip planted in October, 2017, doing well in May, 2018.**

However, by the end of July, one of the beech whips and the original oak whip had disappeared. A local resident planted an oak from her own garden to replace the missing one but the beech has not, so far, been replaced. Further damage occurred to the all three remaining whips throughout late summer and autumn, including one of the oaks being driven over by a contractor (not from idverde) working in the Park!

In November, all three remaining trees appeared to be in poor condition. It must be emphasised that this has nothing to do with poor planting or lack of care by the FoEP; it has everything to do with accidental (and possibly some deliberate) damage by Park users.

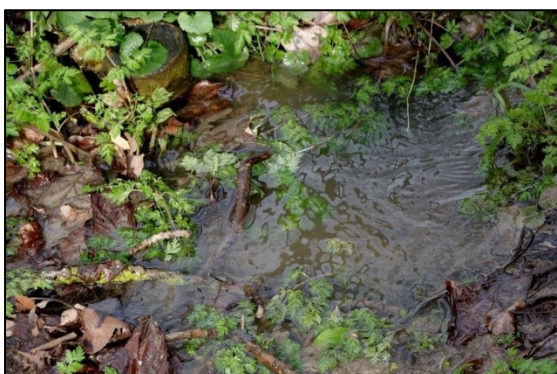
At Easter, water was flowing swiftly through the pond system and into the Lake. The Lake itself was full and rapidly overflowing. However, the pipe carrying overflow water from the Lake to the main surface water drain across the Park was fractured and water was leaking out onto the 'dry' side of the lake embankment and flowing down to a very large 'puddle' at the foot of the embankment (Figs 16 & 17.) It is possible that a blockage further along the pipe was also contributing to the leak. The FoEP was asked by NBC to liaise with Anglian Water to solve the problem and, after several visits by engineers, the issue was dealt with.

**Fig. 16: Leakage from the Lake overflow (Easter, 2018).**

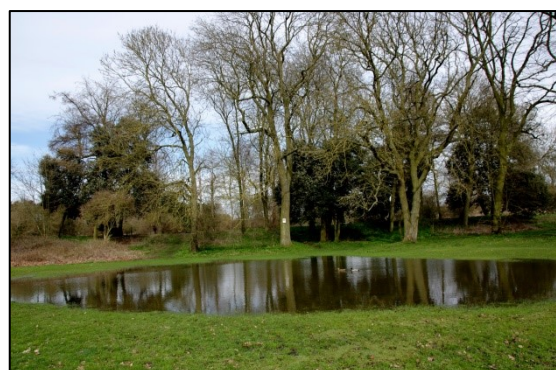
**Fig. 17: Large puddle of leaked overflow water formed at the bottom of the Lake embankment.**

This leakage does raise issues about the structural integrity of the embankment. Apart from underground channels caused by water flow, the bank is riddled with rat holes. As reported

in the February ‘State of the Park’ report, the lake side of the embankment is badly eroded and the structure needs to be examined professionally and further erosion prevented.

7. NBC should arrange for the Lake Embankment to be inspected by suitably qualified engineers and any necessary remedial action taken before further damage to the structure occurs.

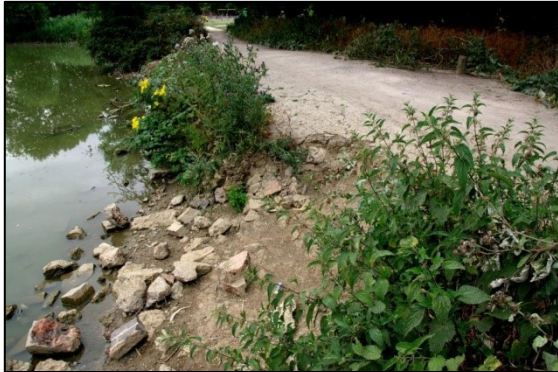
By the end of July, after three months with very little rain, the water level in the Lake was very low revealing serious damage to the lake side of the embankment (Fig. 18). The top surface was also beginning to crack (Fig. 19), further emphasising the need for urgent repair.

**Fig. 18: Lake embankment in July showing severe erosion into Lake.**

Some parts of the embankment are much less badly damaged than shown in Figure 18 because tree roots have helped to stabilize the structure. Although some trees along the embankment should be coppiced to improve the view of the Lake, care should be taken not to damage the root structure.

4. Once such a strategy is implemented, the FoEP should continue to remove bushes and self-seeded trees from the west side (the parkland side) of the Lake Embankment. Trees on the east side of the embankment (the lake side) should be coppiced but not removed, leaving their roots intact to reduce erosion of the bank.

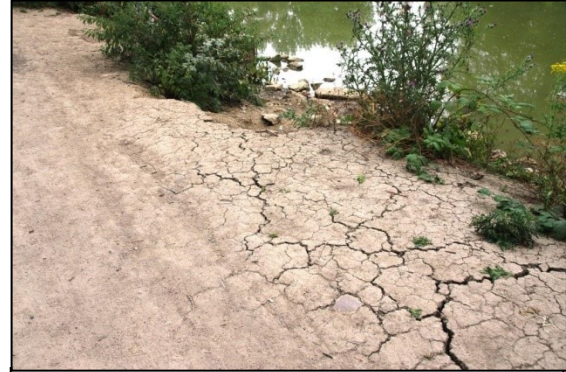
**Fig. 19: Top of the Lake embankment in July showing cracks in surface.**

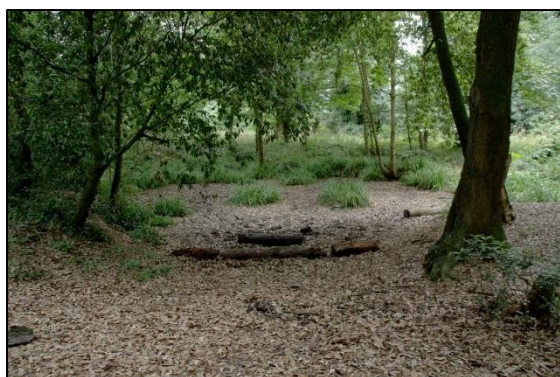
The top pond never dries out and contained water even at the height of the 2018 drought. In contrast, the upper middle pond rarely contains more than damp mud even in winter, though it does often have a stream of water flowing through it. The lower middle pond (Fig. 20) is seasonal, usually with some standing water in winter and only wet mud in summer. Both middle ponds dried out completely in 2018. The bottom pond (Fig. 21) usually contains water throughout the year but at the height of the 2018 drought it contained only wet mud.

**Fig. 20:** Lower middle pond in July, 2018. This pond usually dries out in summer.

The long term plan for these ponds is that the upper middle pond should be kept as a wet habitat without standing water, whereas the three other ponds should be dredged and the water level raised somewhat by damming the outlets. All three ponds are heavily shaded and would benefit if surrounding trees were heavily pruned and most of the self-seeded

8. The FoEP should pursue its aim of getting estimates for dredging three of the ponds and other suitable work in the Pond Area, including removing many of the self-seeded 'weed trees' that shade the ponds and the Crescent Rock Garden. Plans for improving the ponds and the surrounding area should be produced by the FoEP, and agreed with the EPMC, before seeking external funds to implement the plans.

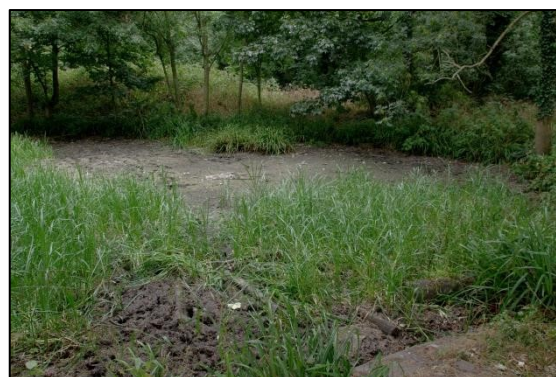
**Fig. 21:** Bottom pond in July, 2018. Though it appears dry, the central area is deep wet mud.

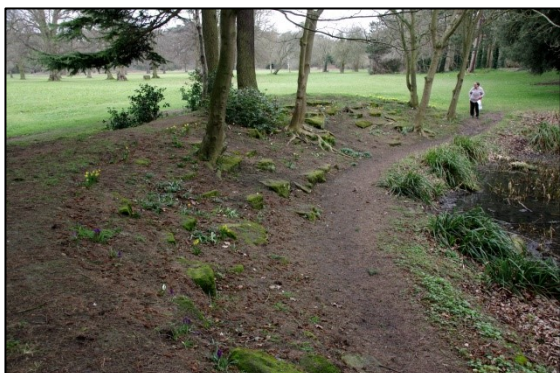
**1. The Crescent Rock Garden** (Figs. 22 & 23) was started in 2011 on an area that was a rockery in the Weston Favell House Estate during the first part of the 20<sup>th</sup> Century. The rock garden had been built on an embankment facing the bottom pond but had long been abandoned. It was covered in weeds and partly shaded from sun and rain by a number of undesirable self-seeded ‘weed trees’ as well as desirable specimen trees. Ground conditions were also very poor, the soil being rich in clay and covered in pine needles from surrounding trees.

**Fig. 22:** The Crescent Rock Garden (22<sup>nd</sup> March, 2018).

Over the years the area has been weeded several times, compost has been incorporated into the soil and a few of the smaller weed trees have been removed. The area has been planted with, among other things, spring bulbs, cyclamen, wood anemones and primroses. The plants have not done particularly well in the dry, shaded (and probably acidic) conditions but several park users have commented on the improvement that the plants make to the area (Fig 23). The garden would benefit if more of the self-seeded trees were removed but, at present, this is beyond the scope of the FoEP. Even if such trees were removed, the area would still be shaded by desirable species.

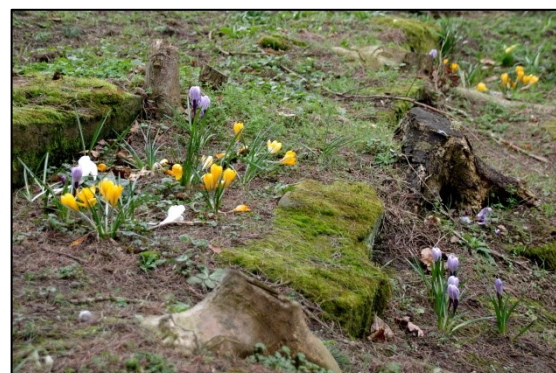
**Fig. 23:** Flowers on the Crescent Rock Garden (22<sup>nd</sup> March, 2018).

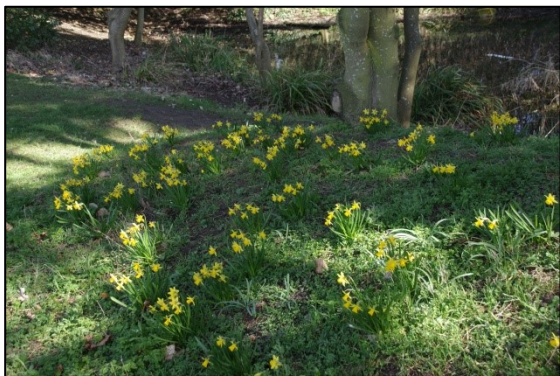
In recent years the garden has been extended to include part of the 'back' of the embankment (i.e. the side facing the open parkland). Growing conditions on the northern part of this area (Figs. 24) are better than on the slope facing the pond but are still problematic. Further along, in the area currently being developed, the bank is even more heavily shaded though, as the picture shows, some sunlight does get through (Fig. 25).

**Fig. 24:** Northern end of the 'back' of the Crescent Rock Garden (26<sup>th</sup> March, 2018).

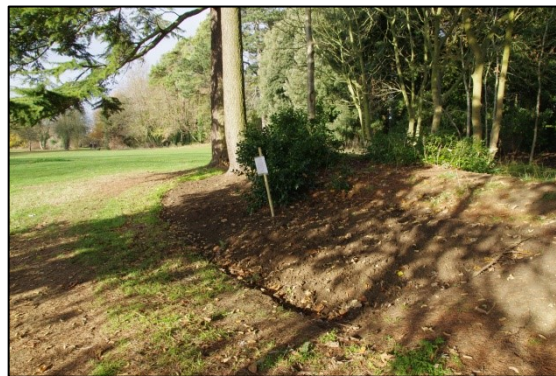
**Fig. 25:** Area currently being developed further along the 'back' of the Crescent Rock Garden.ch,

It is hoped that, as this area is developed, plants can be found that will thrive under the unfavourable conditions. Some years ago, a visitor from the RHS recommended hellebores but when two were planted one was stolen and the other trodden down. Any plants chosen therefore need to be inexpensive or donated.

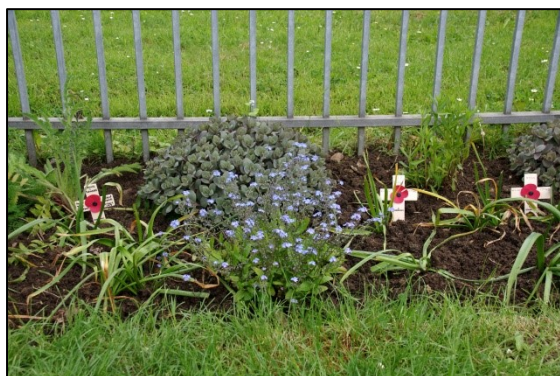
This year, being the 100<sup>th</sup> anniversary of the ending of World War I, the border also served as the FoEP's own 'Remembrance Garden' with forget-me-nots planted along the front of the garden and a few poppies added to the general mix. Park users were invited to place crosses in the border to remember friends or relatives who have died (Fig. 26).

**Fig. 26:** In 2018 the Herbaceous Border also served as a Garden of Remembrance (28<sup>th</sup> May, 2018)

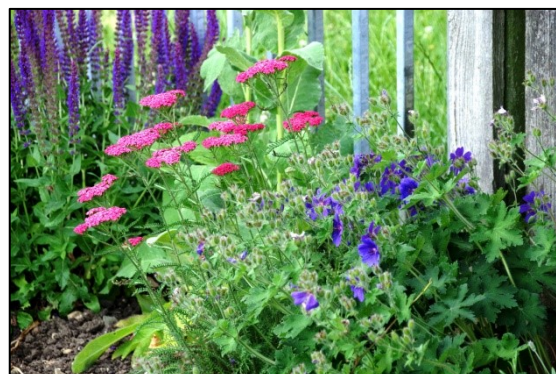
The plants in this garden are doing well (Fig. 27) though their arrangement could be improved. This will be achieved as the garden is developed further. The FoEP is also

**Fig. 27:** Plants on the Herbaceous Border doing well in 2018 (21<sup>st</sup> June, 2018).

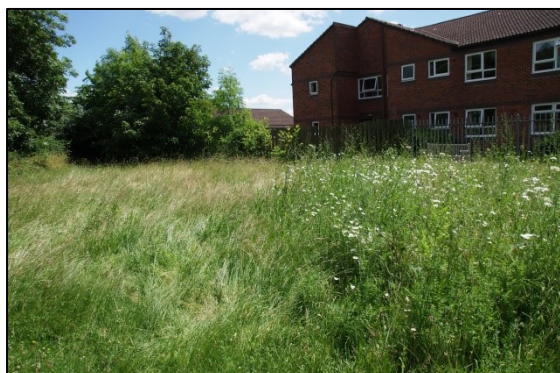
This year, the meadow had a better balance of plants (Fig 28) but, as in 2017, large areas were dominated by chicory which grew very tall. The meadow was attractive to pollinators (Fig. 29) but it received a mixed reception from residents, some of whom took a particular dislike to the chicory. When the contractors cut the meadow at the end of the season, a strip of mainly chicory was left against the Eleonore House fence. It is currently being cut down by FoEP volunteers (Fig 30).

**Fig. 28:** Seeded Meadow on the right, uncut grass on the left (21<sup>st</sup> June, 2018).

After careful consideration I now believe that the seeded meadow should be redeveloped as a wildflower garden. Instead of a wide mix of grasses and wildflowers such as might be found in a natural meadow, the area could be planted with carefully selected wildflowers with possibly a few grass species. Such a garden would need continuous maintenance to prevent it from becoming colonised by other plants (especially those introduced in previous seasons). The garden may be too large to be maintained by the available volunteers so it is recommended that it be divided into sectors. Each year, some sectors could be maintained but others could be left uncultivated to see what develops. This would be no worse than the present situation and could be much better. A possible layout for a new garden is shown in Fig. 31).

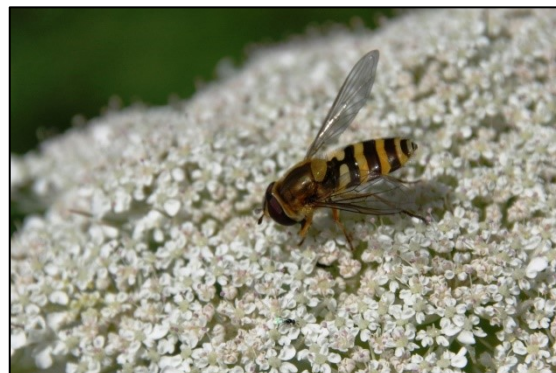
**Fig. 29:** Hover fly on Yarrow in the Seeded Meadow (21<sup>st</sup> June, 2018).

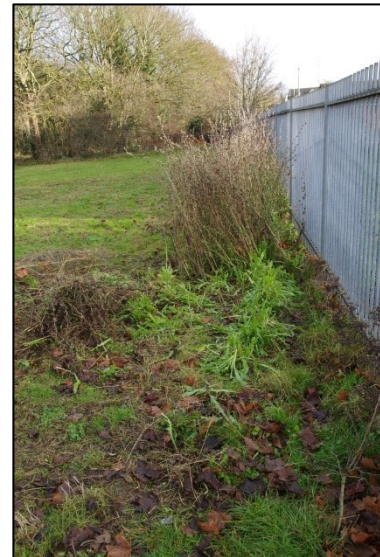
**Fig. 30:** Tall vegetation (mainly chicory) currently being cut down by FoEP (26<sup>th</sup> Nov., 2018)

10. The Seeded Meadow has been successful in attracting pollinators but some residents do not like the taller plants such as chicory. The FoEP should pursue its plans to convert the Seeded Meadow into a Wildflower Garden which, it is hoped, will benefit wildlife but also be appreciated by park users.
