EASTFIELD PARK NORTHAMPTON

STATE OF THE PARK

January, 2016

Eastfield Park Management Committee

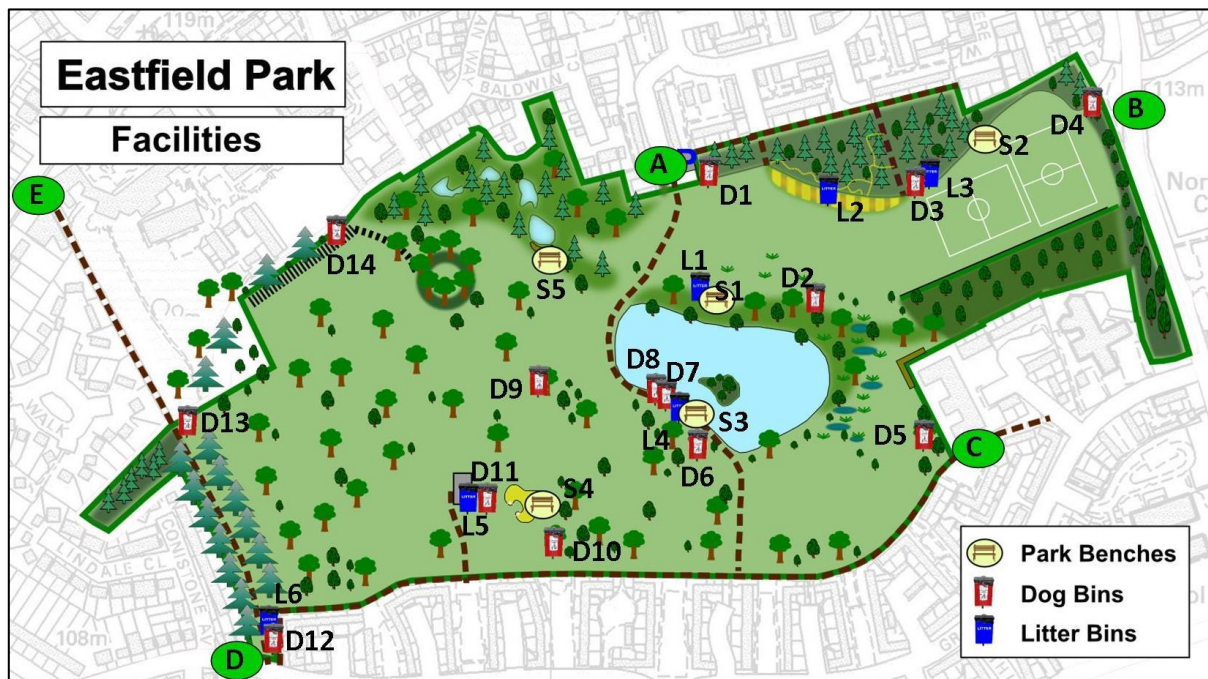
Vic Smith and Kevin Skerry assessed the state of equipment and facilities (Fig 7) in the Park on a six point scale using the criteria shown in Table 1. Since the limits of each category are rather arbitrary, assessments were often recorded as falling somewhere in a range between codes: e.g. '3/4' somewhere between satisfactory and good. The results of the assessments are shown in Table 2 where unsatisfactory situations are shown in red, brown or orange

Figure 7: Equipment and facilities in Eastfield Park. A: Skiddaw Walk entrance, B: Booth Lane entrance, C: Eleonore House entrance, D: Greenfield Avenue entrance, E: Kettering Road entrance, D1 to D14: Dog bins, L1 to L6: Litter bins, S1 to S5: Park benches.
